# Centrifugal Compressor Case Study

## Gas Machinery Conference October 4-6, 2010 Phoenix, AZ

## Centrifugal Compressor Case Study

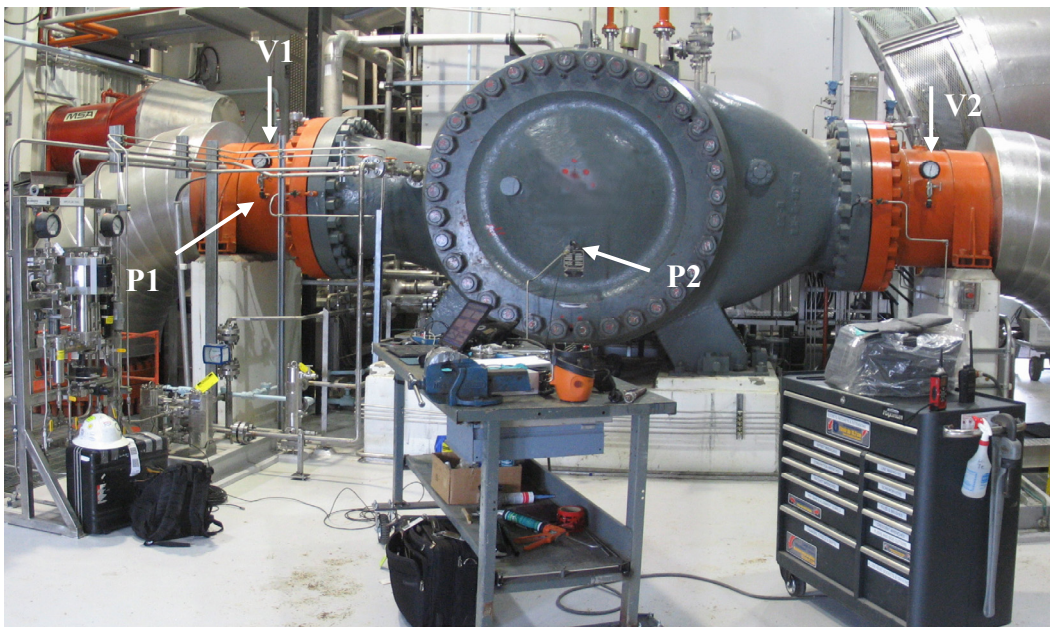
Figure 1. Unit A2 with initial test points marked.

Subsequently, testing of one centrifugal compressor (A2) was done on January 12, 2010 with the primary objective to look for pulsation induced issues. Onsite discussions with plant personnel revealed that a loud noise and vibration of the piping developed at higher operating speeds – again supporting the likelihood of pulsation. Figure 1 shows the unit tested with suction on the right hand side of the photo and discharge on the left. Initially, peak hold pulsations were measured at the compressor discharge and compressor suction eye (marked as points P1 and P2 respectively on the photo) over a speed range of 3600 – 4500 rpm. As the speed increased, the pulsation in the discharge line increased and spiked at the upper end of the speed range (see Figure 2). The peak pulsation was 24 psi pk-pk (compared to a discharge pressure of approximately 825 psig). There is no guideline, but that pulsation is approximately 3% of the mean pressure. In comparison, the pulsation in the suction eye was considerably lower throughout the tested speed range (less than 0.2% of mean pressure) and did not develop a significant single peak (see Figure 3). The frequency of the peak pulsation in the discharge was 1274 Hz which was 17X the run speed and equaled the number of vanes in the impeller (blade pass frequency or BPF). The noise in the building changed when the spike in the pulsation

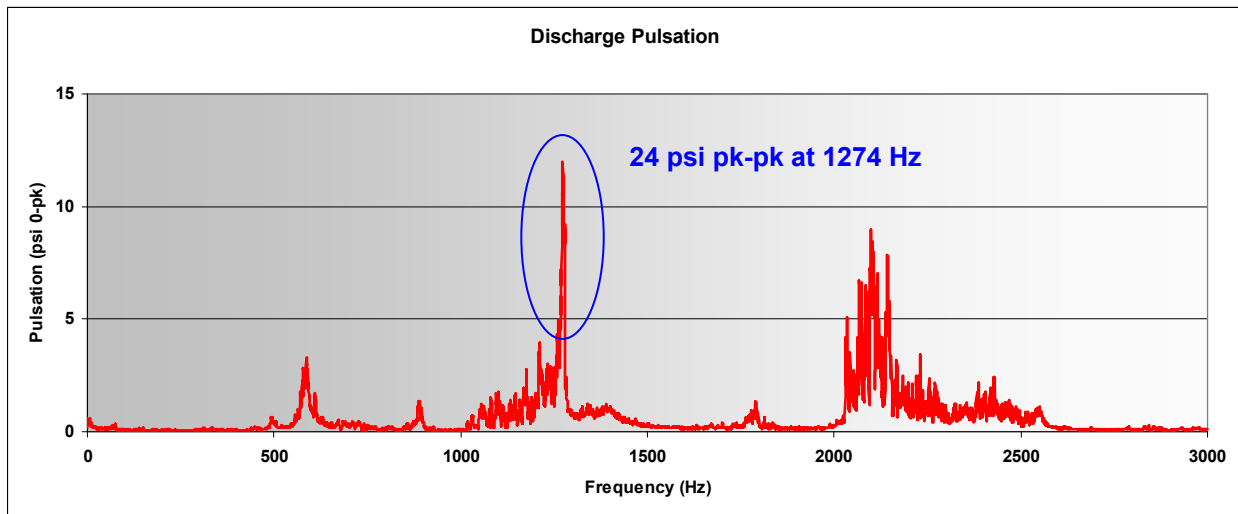
Figure 2. Pulsations in the discharge piping (P1) over 3600 – 4550 rpm.

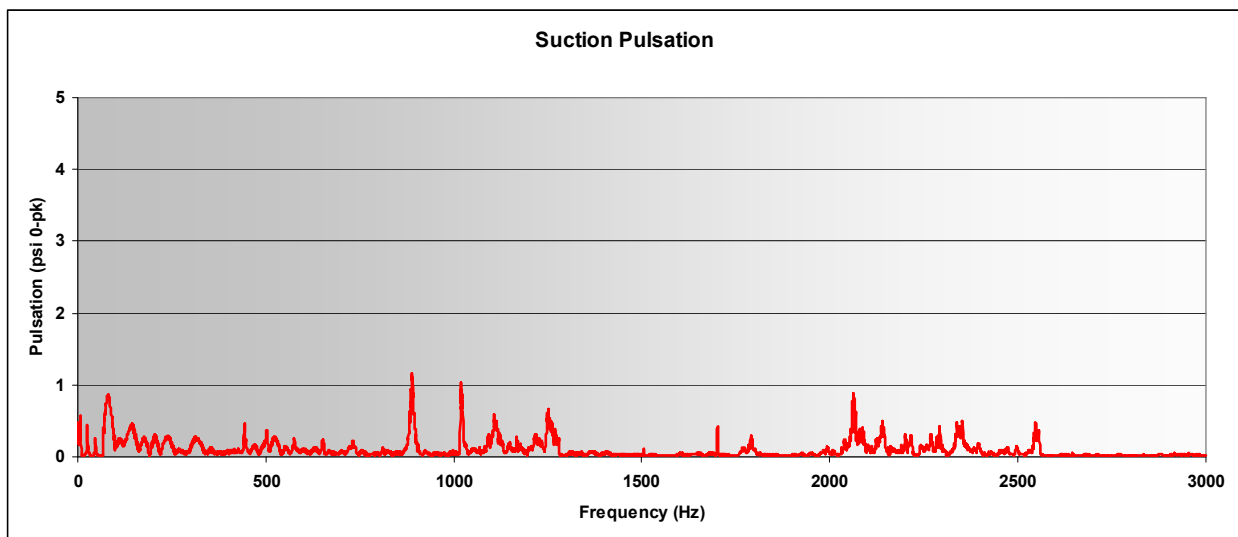
Figure 3. Pulsations in the compressor suction eye (P2) over 3600 – 4550 rpm.

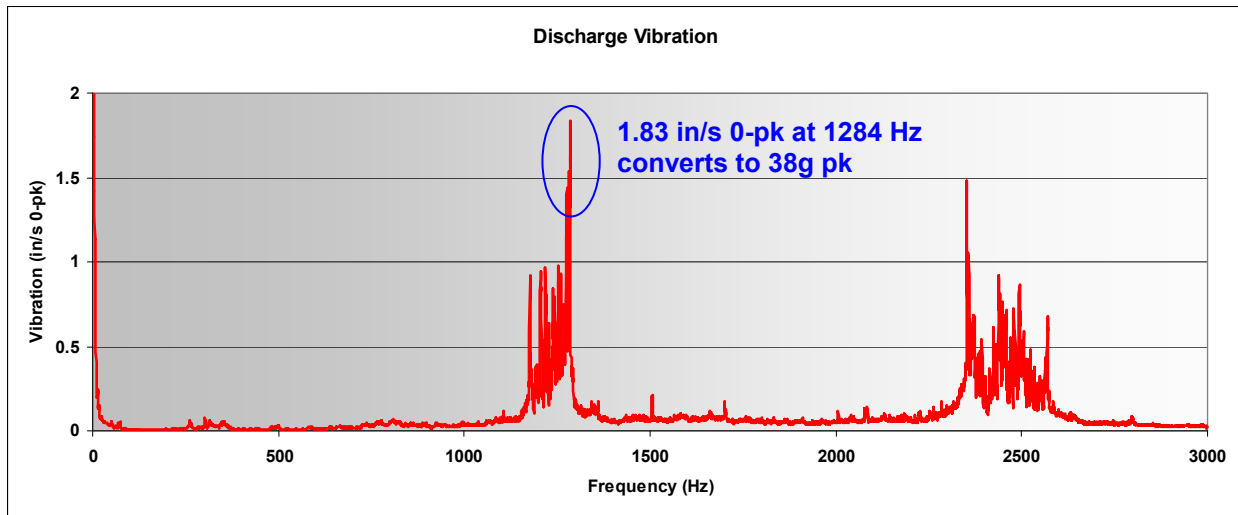
Peak hold vibrations were then measured on the discharge and suction piping beside the temperature instrumentation immediately adjacent to the compressor (marked as points V1 and V2 respectively on the photo) over a speed range of 4100 – 4510 rpm (Figures 4 and 5). As with the pulsations the vibration on the discharge side was significantly higher than the suction side. The discharge piping is 36"OD with 0.75" wall thickness. The peak vibration on the discharge was 1.83 in/s pk at 1284 Hz. Again that frequency was equal to blade pass at 4510 rpm. The vibration is equivalent to 38 g's peak in acceleration terms. Instrumentation that is rated for vibratory service often has an acceleration limit of 10 g's peak. No wonder the RTD's have been failing!

Figure 4. Vibration on the discharge piping beside the thermowell (V1) over 4150 – 4510 rpm.

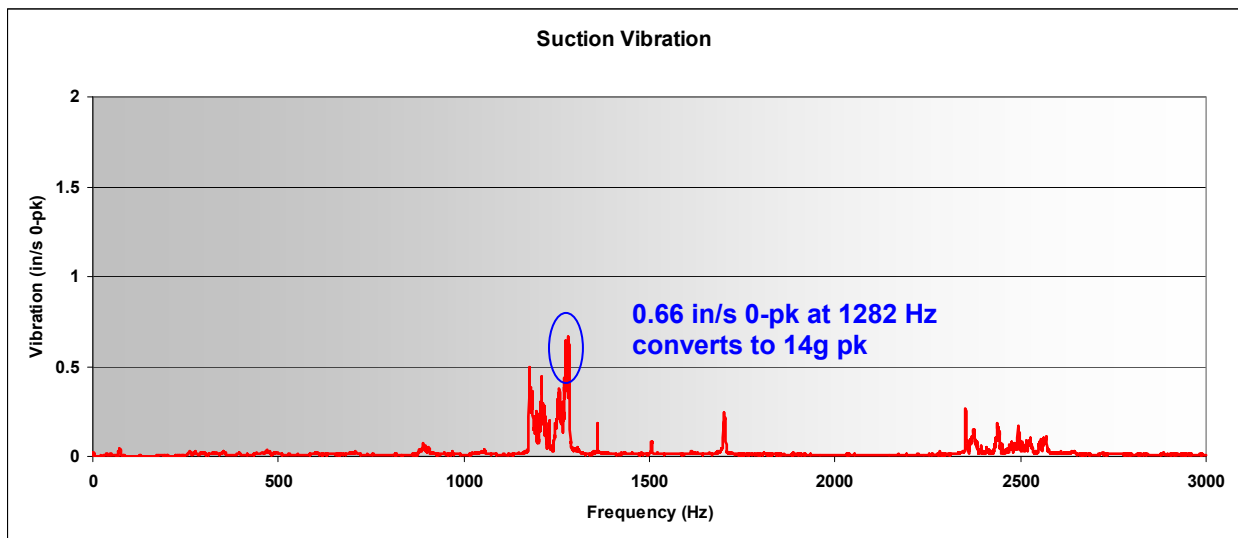
Figure 5. Vibration on the suction piping beside the thermowell (V2) over 4150 – 4510 rpm.

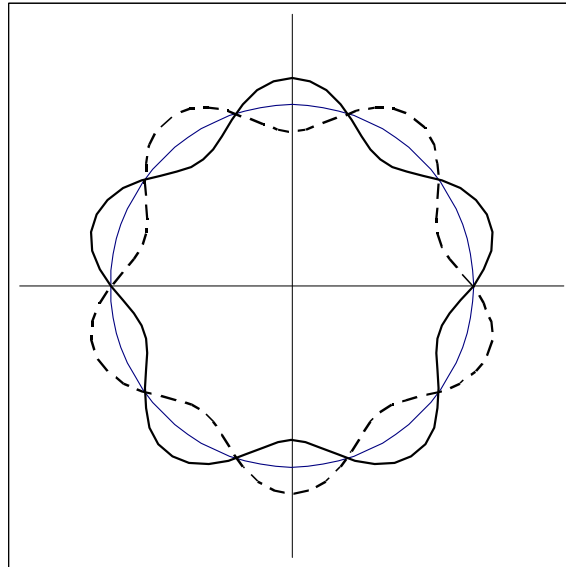
The next step was to conduct an operating deflection shape (ODS) analysis on the piping. The amplitude and phase of the vibration were measured circumferentially around the discharge line beside the thermowell. Vibration at the thermowell was used as a reference. The unit's speed varied during the measurements over a speed range of 4515 – 4550 rpm, but the results were good enough to show that the pipe had a five lobe vibration shape (see Figure 6).

Figure 6. Circumferential mode shape of the 36" discharge pipe with 5 lobes

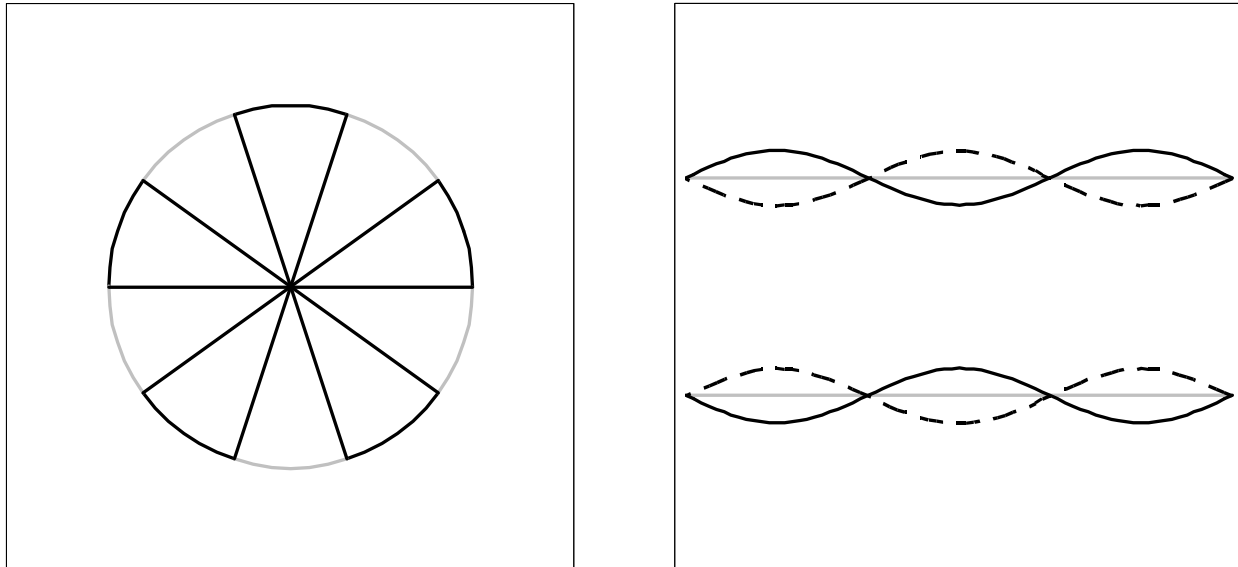
Further study of the problem was conducted to see if coincident acoustic and mechanical natural frequencies could be confirmed analytically. First calculations were performed on the acoustic natural frequencies of the discharge piping. To limit the complexity of the actual geometry, these calculations were limited to the straight run between the discharge flange the first elbow and assumed a rigid pipe wall. At the high frequencies and dimensions, we are not looking at simple plane waves in the pipe. There are many acoustical natural frequencies with transverse and axial components to the mode shape. But interestingly, one of the frequencies that came out of the calculation matched the measured frequency relatively closely (1261 Hz vs 1274 Hz). That acoustical mode had 5 high pressure lobes in one plane and 3 nodes along the axial length (see Figure 7). That obviously matched the ODS measured on the pipe at one circumference of the discharge line. How about along its length?

a) Plane acoustic mode component      b) Axial acoustic mode component  
Figure 7.      Acoustic mode  $i=5$  (plane),  $j=3$  (axial),  $k=0$  (circle)

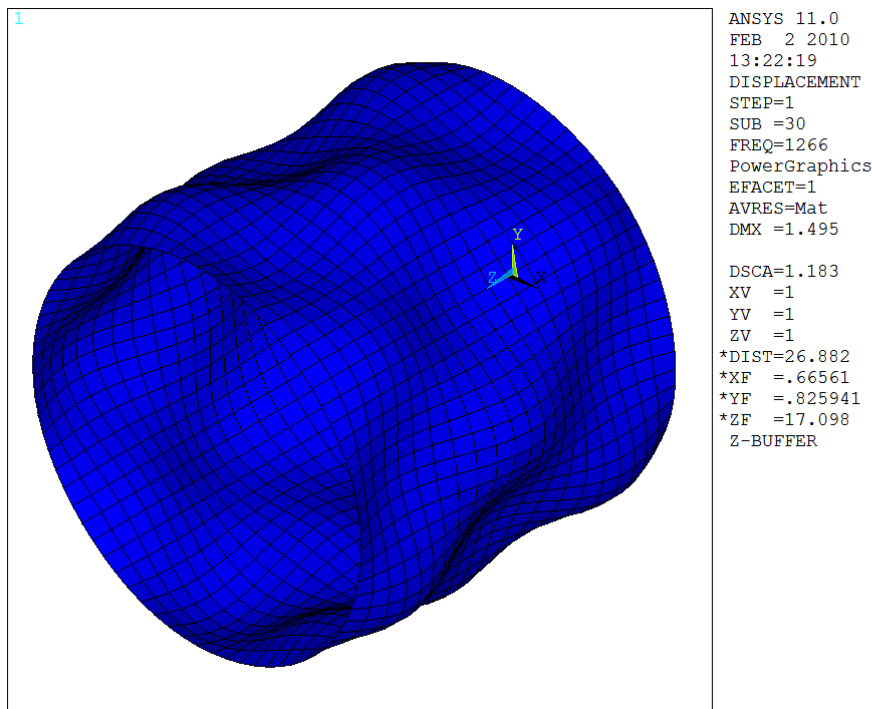
A finite element model of the pipe shell was then run for the same length of discharge pipe and a matching mode shape was found at 1266 Hz. See Figure 8 and 9 below. The analytical results confirmed that not only were there coincident acoustic and mechanical natural frequencies, but that they had corresponding mode shapes. Therefore they would be very highly coupled. That is, the shape of the pipe shell mode in both the circumferential and axial directions matched the pressure distribution inside the pipe caused by the acoustic natural frequency.

Figure 8.      1266 Hz shell mode of the pipe with 5 lobes circumferentially and 3 nodes axially

- 3.2 Stiffen the piping to alter the mechanical natural frequencies of the discharge piping. Of particular concern are the shell modes near blade pass frequency. This may be accomplished by using thicker wall pipe or adding external stiffeners. A thicker spool piece (more than 0.75" wall thickness) would move the natural frequency of the problematic mode to approximately 1400 Hz. The corresponding acoustic natural frequency would be approximately 1270 Hz. This calculation is based upon changing only the straight pipe between the discharge flange and the first elbow. It would be prudent to change the wall thickness of the flange and the first elbow as well. This modification would still allow the acoustic natural frequency to be excited by the blade pass. However, the response of the pipe shell would be much less due to the separation between the mechanical natural and forcing frequencies.

- 3.3 Alternatively add internal stiffeners/splitters to alter both the mechanical pipe shell modes and the acoustical modes of the discharge spool cavity. One potential solution is to weld cross plates in the ID of the spool immediately downstream of the compressor discharge flange to the first elbow. The plates (1/2" thickness minimum) would significantly increase the acoustic natural frequencies of the spool. As well there would be some stiffening of the mechanical natural frequencies (pipe shell modes) and those would be somewhat higher than the present design. Both would then have separation from the 17X blade pass frequency. This recommendation is based upon very approximate calculations. If this is the chosen modification additional calculations should be done to check the many acoustic and mechanical natural frequencies against blade pass to ensure that another mode would not be excited.

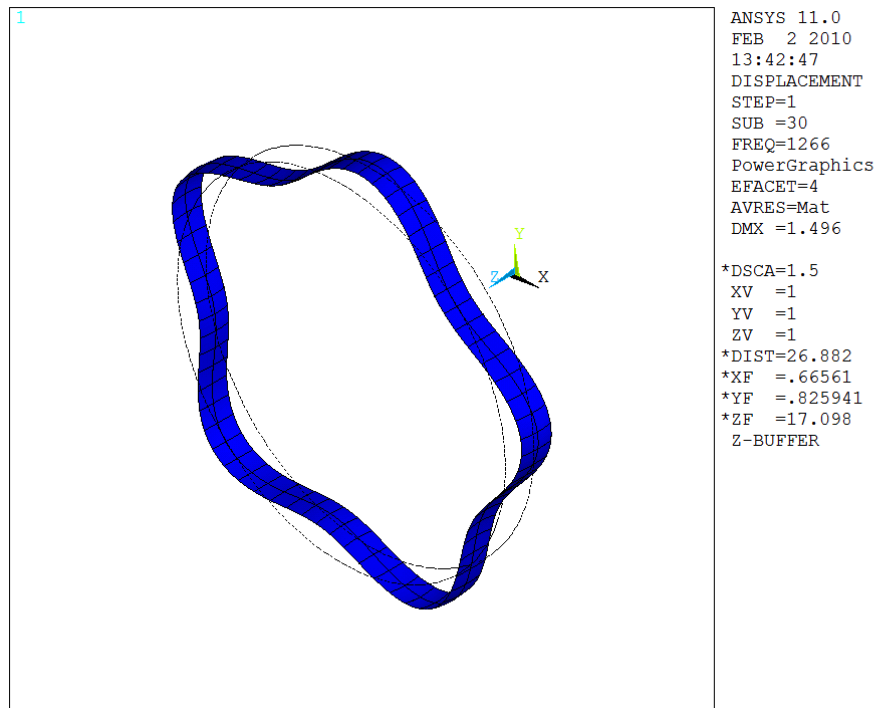
Figure 9. A selected ring of the pipe shell mode to show the 5 lobes more clearly

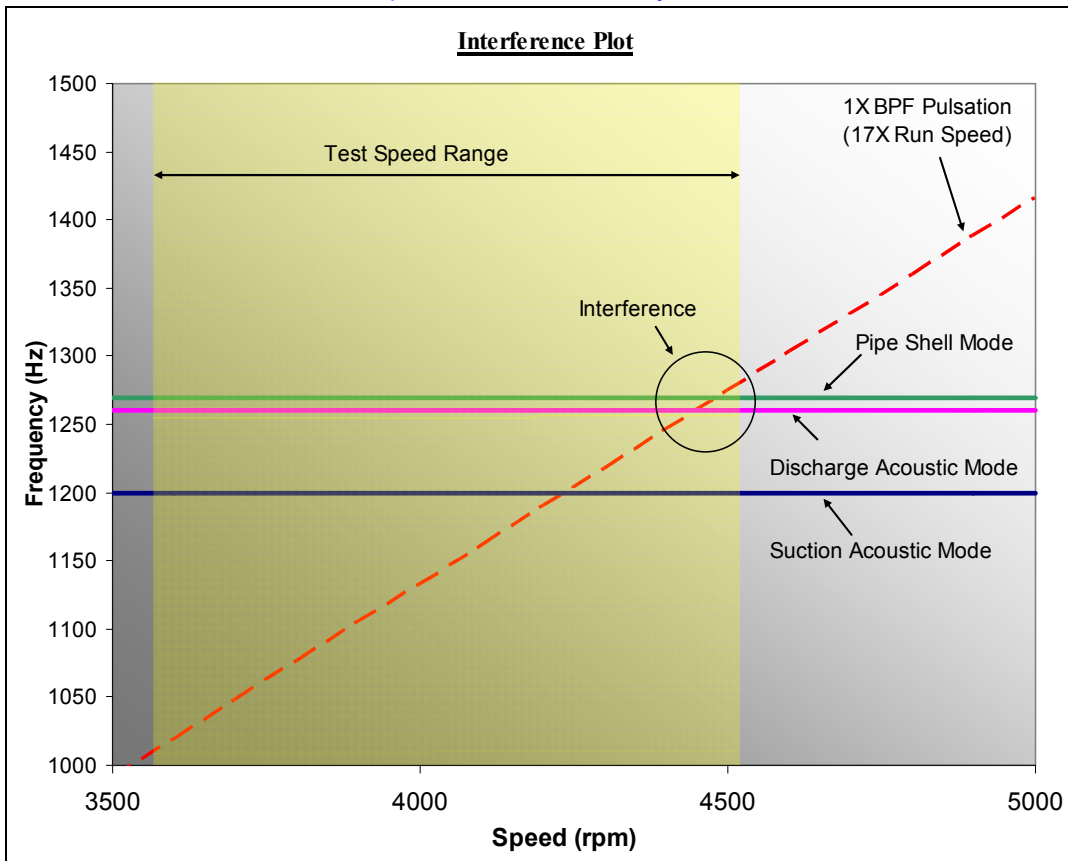
An interference plot was created (Figure 10) which clearly shows the “perfect storm” that occurs when the compressor is running near 4500 rpm. Pulsations at blade pass frequency (17X run speed) are the excitation source for the coincident acoustic natural and pipe shell natural frequencies of the discharge system immediately connected to the compressor discharge flange. The suction acoustic natural frequency (for similar geometry, but different pressures and temperatures) is sufficiently separated from blade the resonance until a lower speed. The shell modes of the suction pipe will be very similar to that of the discharge – so there is no speed where both the acoustic mode and shell mode of the suction pipe are excited by the blade pass frequency at the same speed. That is why failures on the suction side were far fewer. Although there was apparently enough energy transmitted from the discharge to cause a few suction RTD failures.

Figure 10. Interference plot showing the intersection of blade pass frequency pulsation (BPF) with the pipe shell and discharge acoustic natural frequencies between 4400 and 4550 rpm.

- 3.1 Change the wheel or aerodynamic package of the compressor to reduce the blade pass source strength. One possibility is to remove the vane diffusers in the casing. This may be tested on one machine soon.

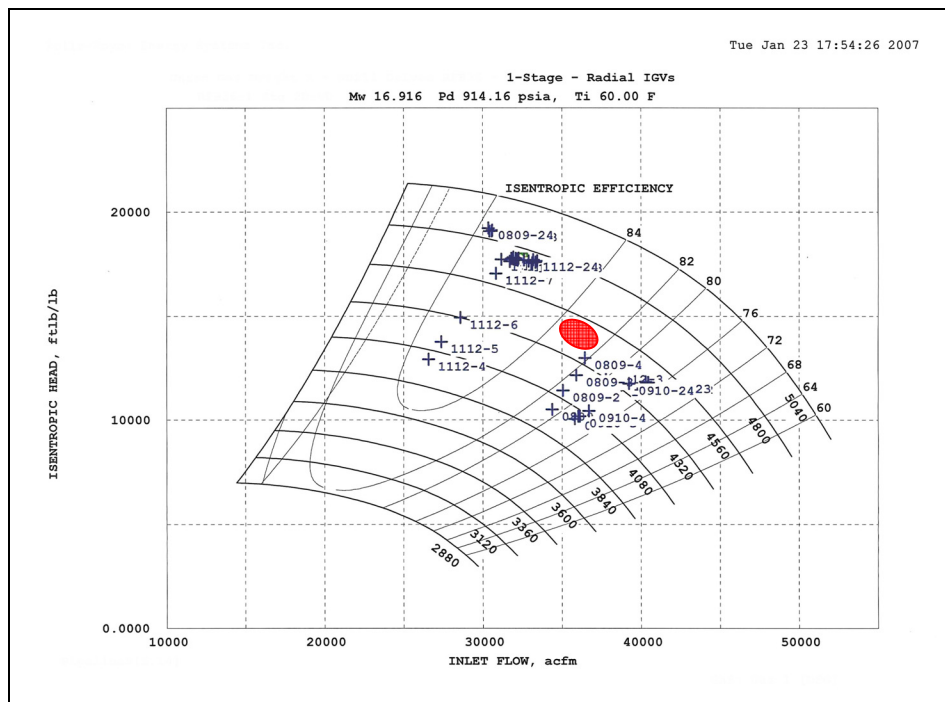
As stated earlier, the source strength of the pulsations will vary with the operating conditions. The operating point at the time of testing is marked on the compressor head curve (Figure 11). The compressor was operating off the best efficiency point, albeit it is not far off.

Figure 11 Head Curve for Unit A compressors. Red oval marks approximate operating conditions when high vibration and pulsation was occurring.

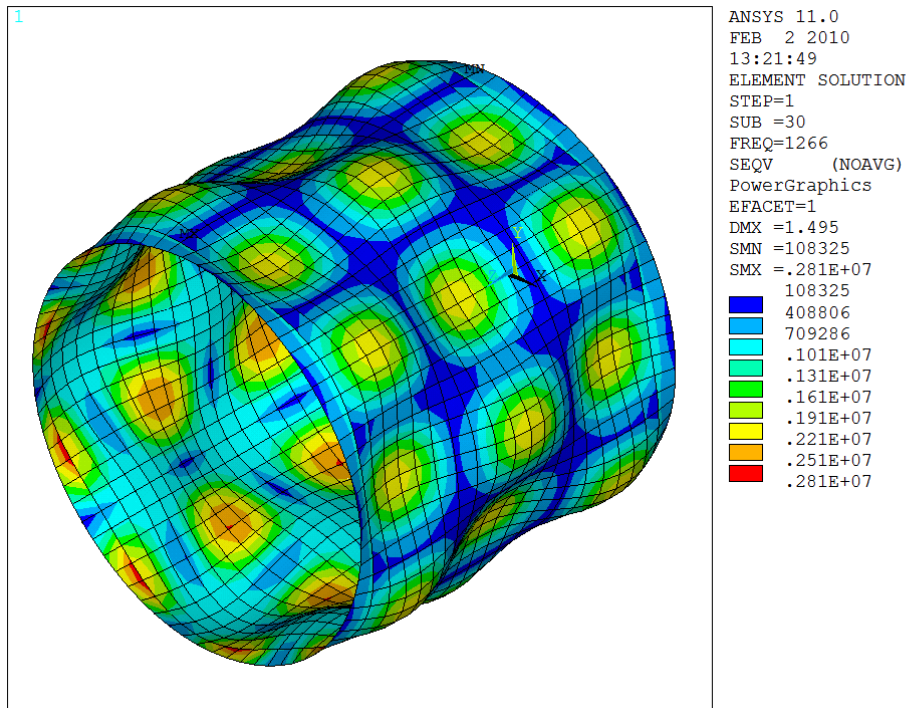
The client had an additional question about the piping vibration. Were the vibrations likely to cause a fatigue failure of the discharge piping itself? Since the finite element model was already available, a stress analysis was completed on the pipe shell mode that was being excited. The finite element model was used to estimate stresses in the pipe shell when the mode was excited to an arbitrary displacement as shown in Figure 12. That calculated stress was then scaled to the actual measured displacement of  $1.87 \times 10^{-4}$  in pk and found to be 710 psi pk-pk. This is well below the endurance limit for carbon steel pipe and allows for some stress intensification at discontinuities in the geometry. Although this indicates there is a very low probability of failure of the pipe itself, it does not mean that small bore connections in the vicinity will have acceptable stress range levels.

Figure 12. Stress plot for the 1266 Hz pipe shell mode.
