INCORRECT VALVE SELECTION ON PLUNGER PUMPS RESULTS IN UNDETECTED HIGH FREQUENCY VIBRATION AND COSTLY FAILURES, A CASE STUDY

Beta Machinery Analysis Ltd. Suite 300, 1615 Tenth Avenue Southwest Calgary, AB, T3C 0J7

For Canadian Machinery Vibration Association 1996 Annual Meeting

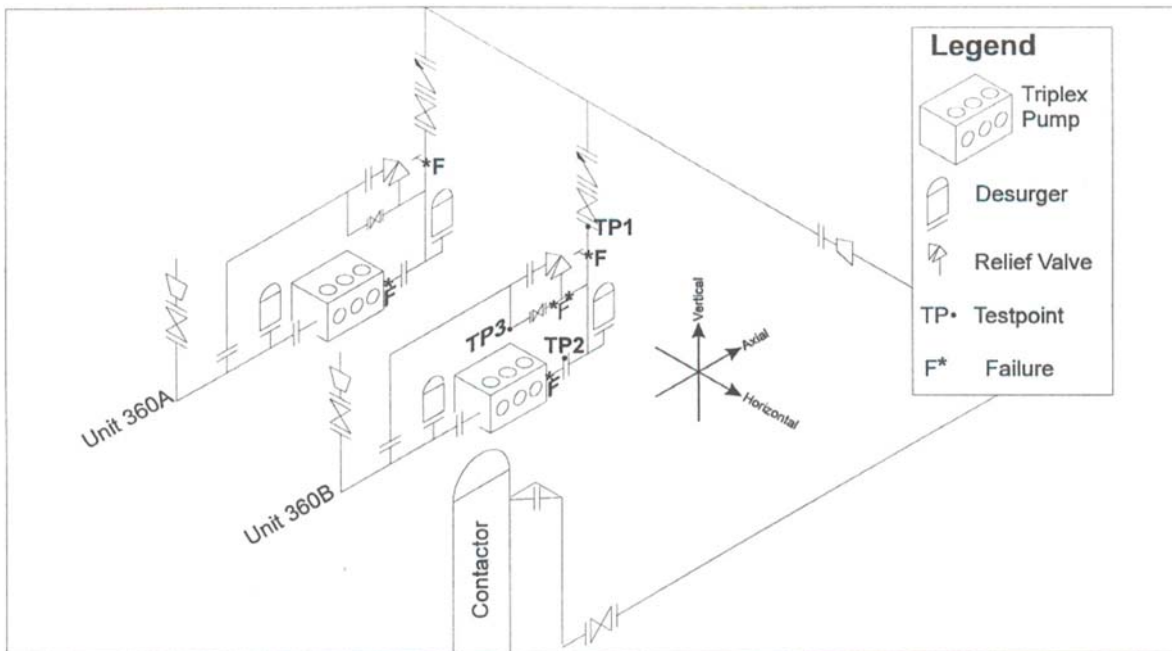
Figure 1 Two identical plunger pumps, with one on 100% standby, are used to remove hydrogen sulfide and carbon dioxide from a natural gas stream. Both pumps experienced failures on the discharge piping.

Figure 1 shows the areas where failures occurred. Both pump discharge system had similar failures.

- the relief valve nipple on the vertical riser directly after the pump discharge,
- the pressure tap nipple at the same location, and
- the top side of the discharge nozzle socket weld.

Originally, the discharge system had been installed without desurgers, which was an oversight. The owners recognized this shortcoming after a few hours of operation, and installed discharge desurgers where fittings were available. Improvement was noted. Later,

they installed a larger desurger for each pump, as close as possible to the pump's discharge. There was a substantial reduction in **perceptible** vibration. However, piping failures continued to occur, each time causing downtime and loss of amine.

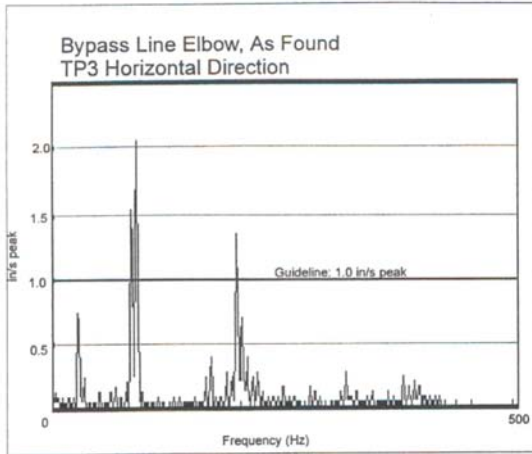
Piping attachments had vibration levels of up to 2.0 in/s pk (Figure 1, TP 3). This level is double the guideline, and explains why the nipples

Figure 2 *Vibration on the piping attachments was double the guideline.*

failed. This vibration was not readily apparent to the human touch, and it was later determined to be a high frequency vibration. See Figure 2.

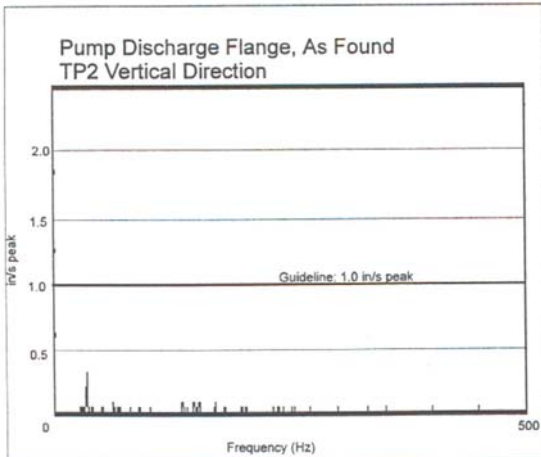
Vibration on the main piping, on the other hand, was well below guideline, based on spectrum analysis. The discharge riser (TP 1) had approximately 0.5 in/s pk vibration in the horizontal and vertical directions. The pump discharge nozzle flange (TP 2) showed vibration of 0.3 in/s at 2X plunger passing frequency. See Figure 3.

Figure 3 *According to the spectrum, vertical vibration on the pump discharge flange was well within the guideline, even though the weld had broken at the pump.*

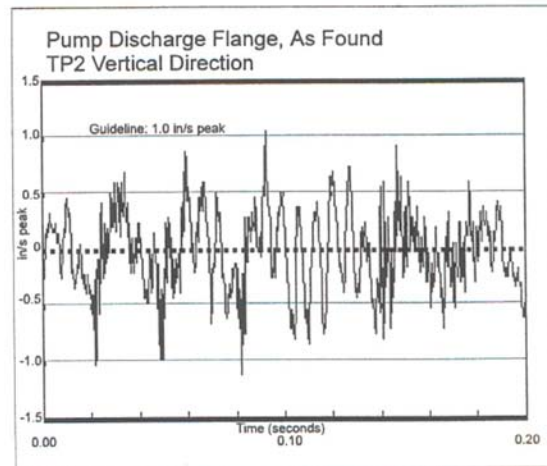
In an attempt to determine why breakage occurred at the pump discharge flange even though vibration was apparently acceptable we measured time waveforms. These revealed a much different picture. On the pump discharge flange in the vertical direction, for instance, (same location as shown in Figure 3), “spiky” positive and negative 1.0 in/s peaks occurred. See Figure 4.

Figure 4 *The time domain pattern showed sharp peaks, with much greater amplitude than that shown in the spectrum*

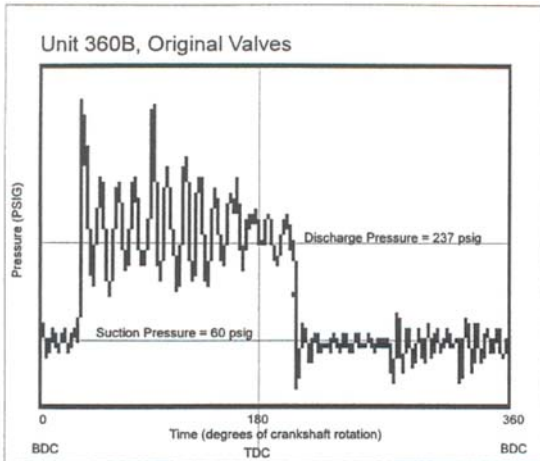
Figure 5 The As Found Pressure-Time curve showed that the valve events were significantly late.

The suction valves closed up to 30 degrees after dead centre, as compared to the expected angle of less than 10 degrees. Similarly, the discharge valves closed up to 23 degrees after dead centre.

On Beta’s recommendation, and with the concurrence of the pump supplier, the owner installed valves with stiffer springs and plastic plates to correct the late valve closures. When the pump was run with the new valves, it was so quiet that operators questioned whether the pump was functioning!

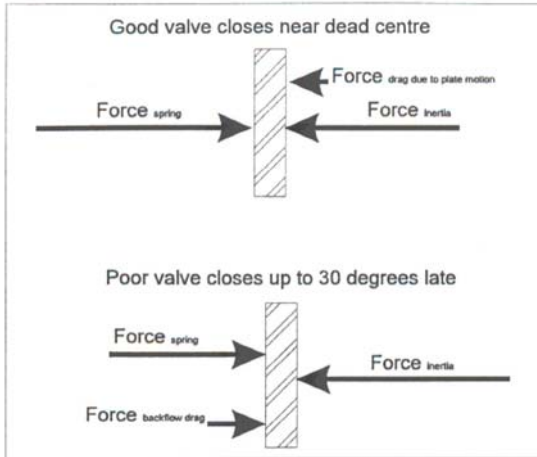
Figure 6 Exaggerated comparison of forces acting to close the valve. If the contribution of the spring to valve closure is less, that of the drag force must be greater.

Consider valve spring stiffness and assume the same free length and installed length (preload). Insufficient spring stiffness could cause the suction valve to close late because there is less contribution from the spring toward forcing the valve to close. To compensate for the lack of force from the spring, drag force from backflow is required to close the valve. See Figure 6. The discharge valve opening is late accordingly, since it must happen after suction closing.

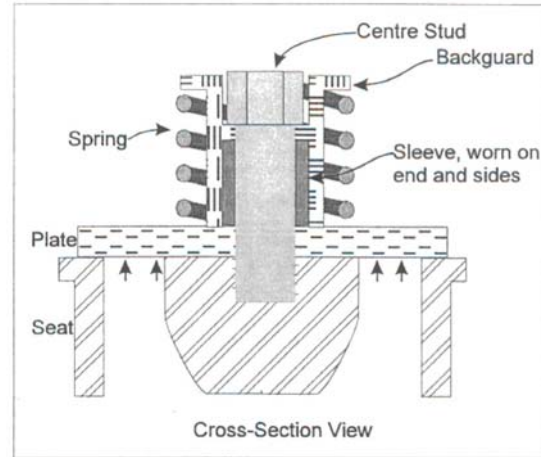
Figure 7 The structure and wear pattern of the valve is an important piece of the puzzle.

When the original valves (with the relatively flexible springs) were removed, we examined them carefully to see if they confirmed our theory. A sketch of the valve cross-section is shown in Figure 7. Typically, the centre bolt was loose and the cylindrical sleeve in the centre of the valve showed excessive wear on both its ends and its sides. Some of the valve plates and backguards were worn. Cavitation damage was found on at least one plunger.

These patterns and modes of failure would suggest that the plate opened more violently than it should have and by travelling farther than it should have, hit the backguard. The repeated impacts could have loosened the nut, allowing the sleeve to move radially. That movement could have allowed the wear that was found on the ends and sides of the sleeve. (Valve flutter and squirming in relation to the guide can also

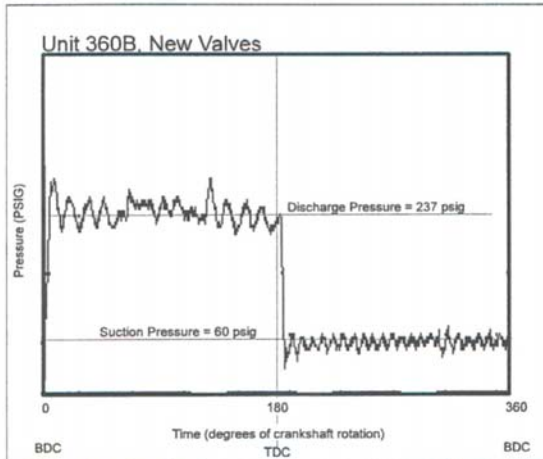
Figure 8 The Pressure-Time curve for the new valves showed closure within 6 degrees of dead centre. Plunger velocity is still slow, and therefore impacts are low.

- the flow rate of the pump had increased to 106 US gal/min, the rated capacity.
- the suction and discharge valve closing angles were about 6 degrees after dead centre. See Figure 8.
- high frequency vibration had decreased. The spectrum showed very little high frequency energy. See Figure 9. The time domain plot showed the vibration to be 0.3 in/s positive and negative, and the large (over 1 in/s) spikes were no longer occurring. See Figure 10.

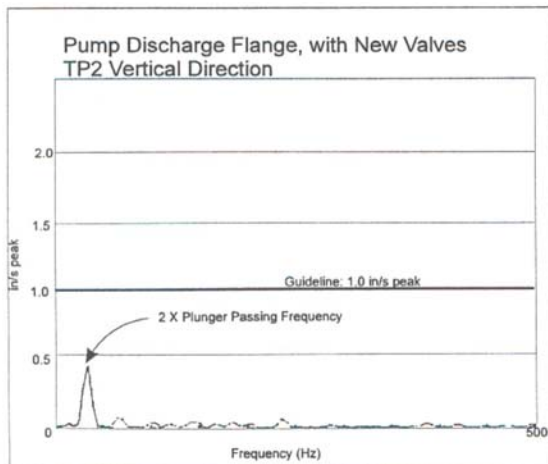
Figure 9 The spectrum related to Figure 9 has little energy at higher harmonics.

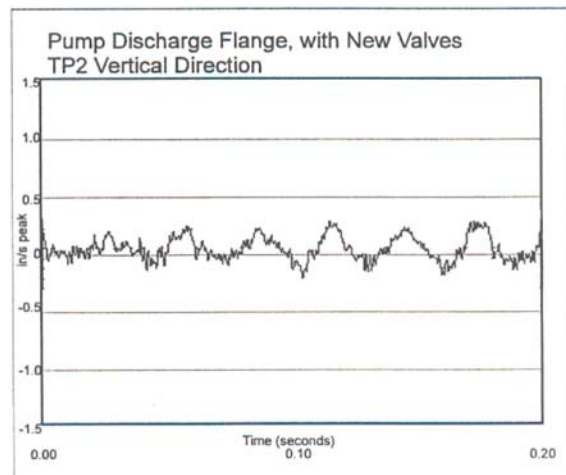
Figure 10 Vibration taken after the valves were replaced showed acceptable levels.
